# Manhole Inspection Summary

Manhole # S43SS\_022MH

Insp Date: **2/22/07 10:00 AM**

**Location** Address: **1738 HOMESTEAD ST**

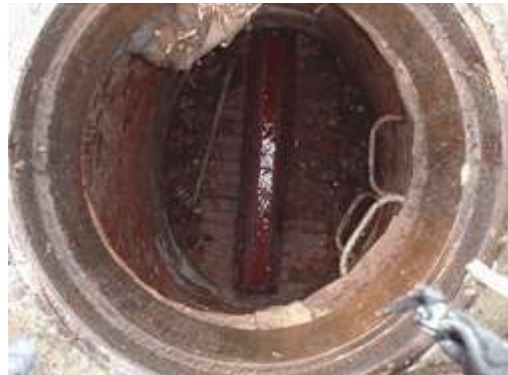
Top View

Bench debris.

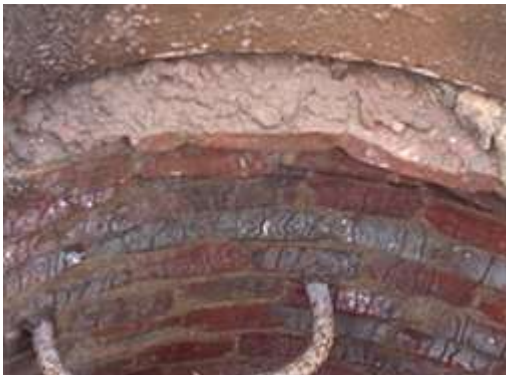
Defect

Frame leaks. Frame offset. Adjustment deterioration and infiltration.

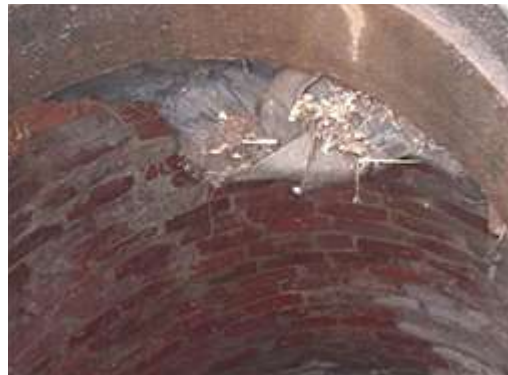
Defect

Adjustment and Barrel infiltration.

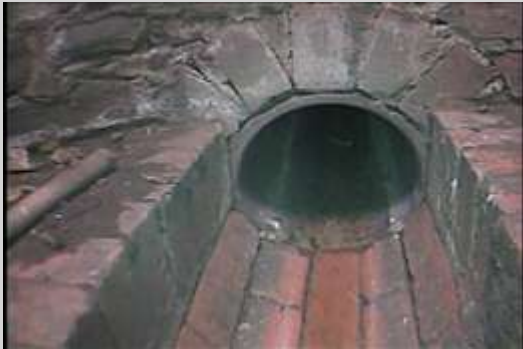
### 8 in. Circular Gravity Sewer Pipe Out @ 12 O'Clock

Channel deterioration.

Infiltration: **Evidence** Pipe Seal Cond: **Unknown**

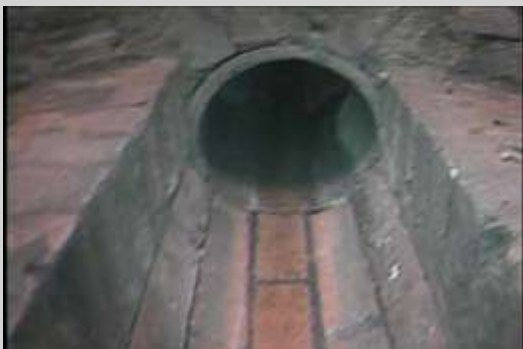
### 8 in. Circular Gravity Sewer Pipe In @ 6 O'Clock

Infiltration: **Evidence** Pipe Seal Cond: **Unknown**
